Central Pier

Summary Fact Sheet

January 2020

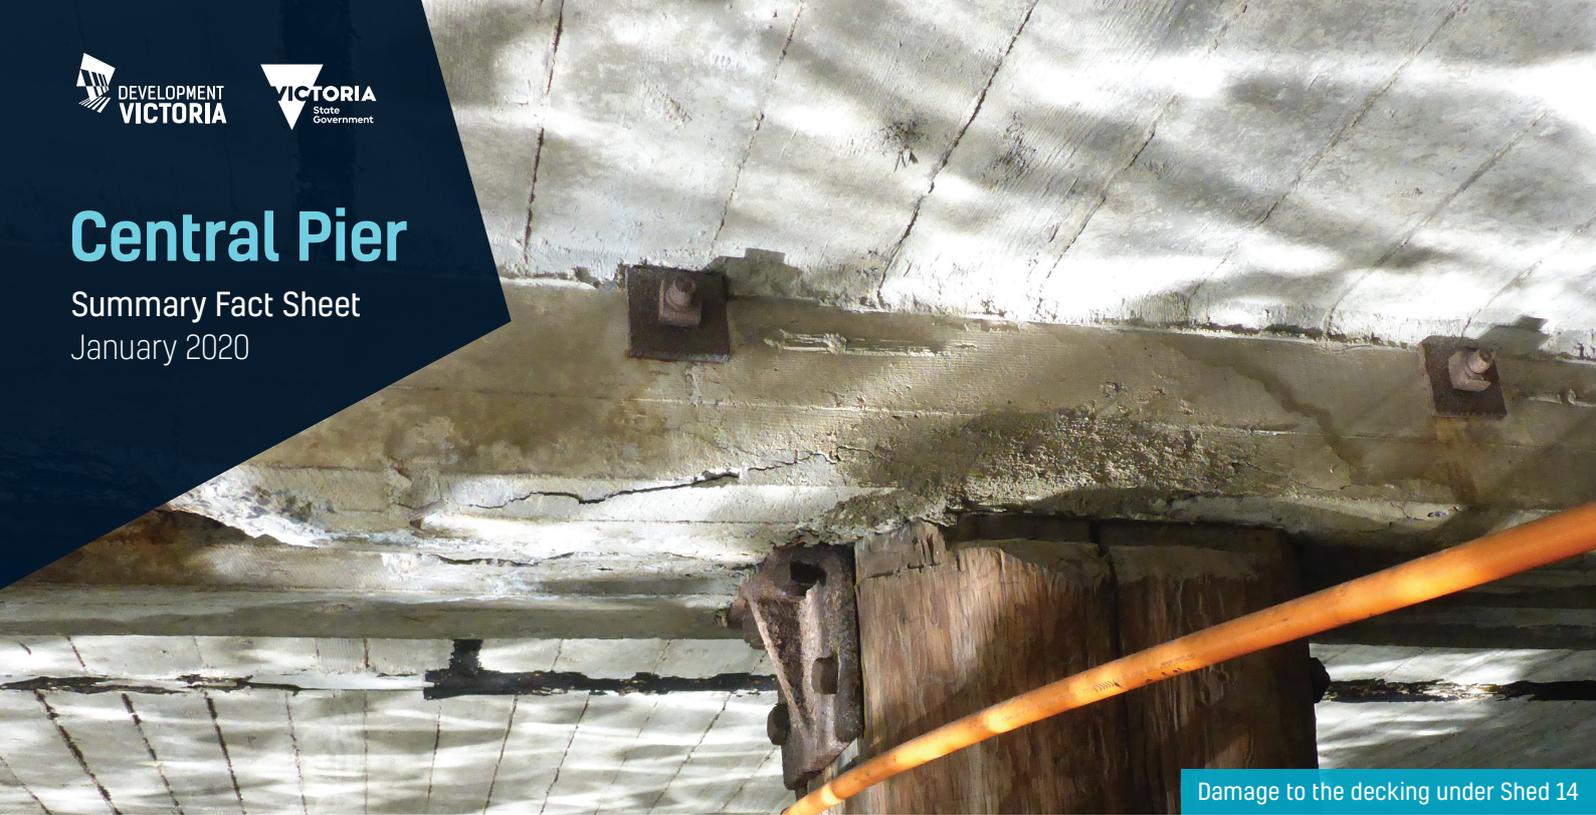
Damage to the decking under Shed 14

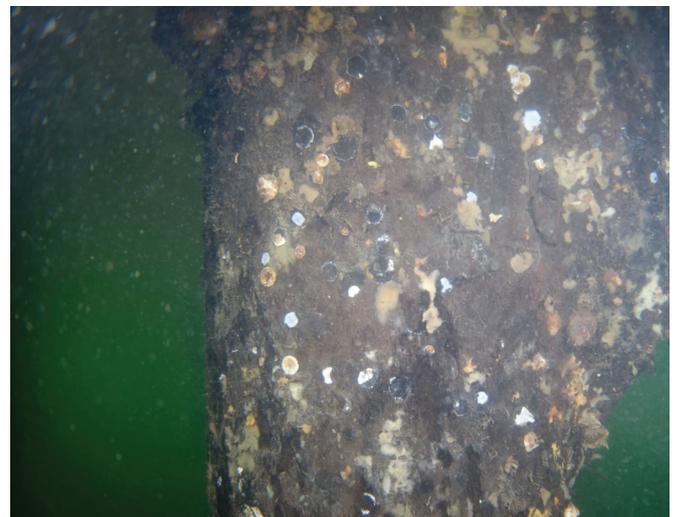
Image left and right: Rot, Marine borer and aggressive marine environment have continued to eat away at the structural supports

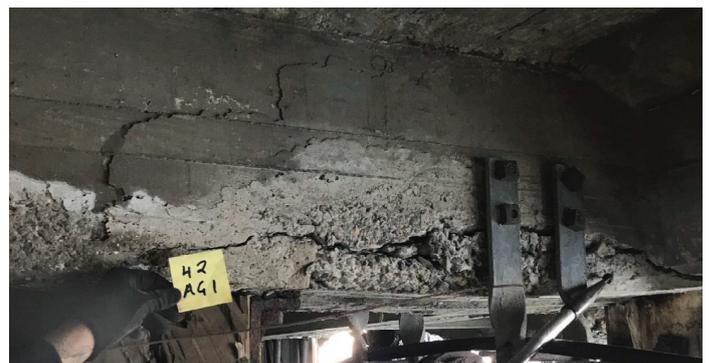
Beam cracking Wharf 14

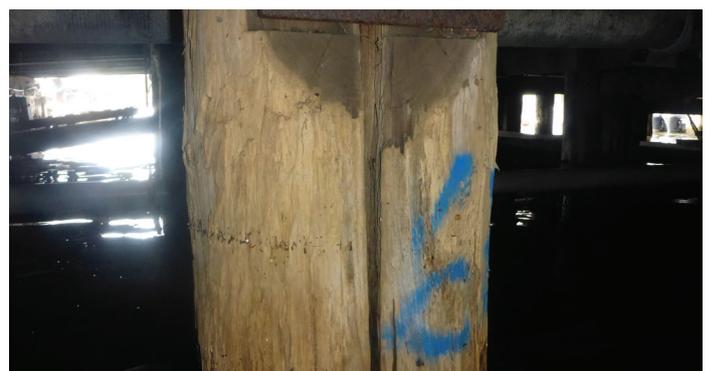
Split pile Wharf 9
