13 January 2022

Development Victoria
Level 9, 8 Exhibition St, Melbourne VIC 3000
Sent via email

RE: CULVERT SPILLWAY INSPECTION OF KNOX DAM, 621 BURWOOD HIGHWAY, KNOXFIELD

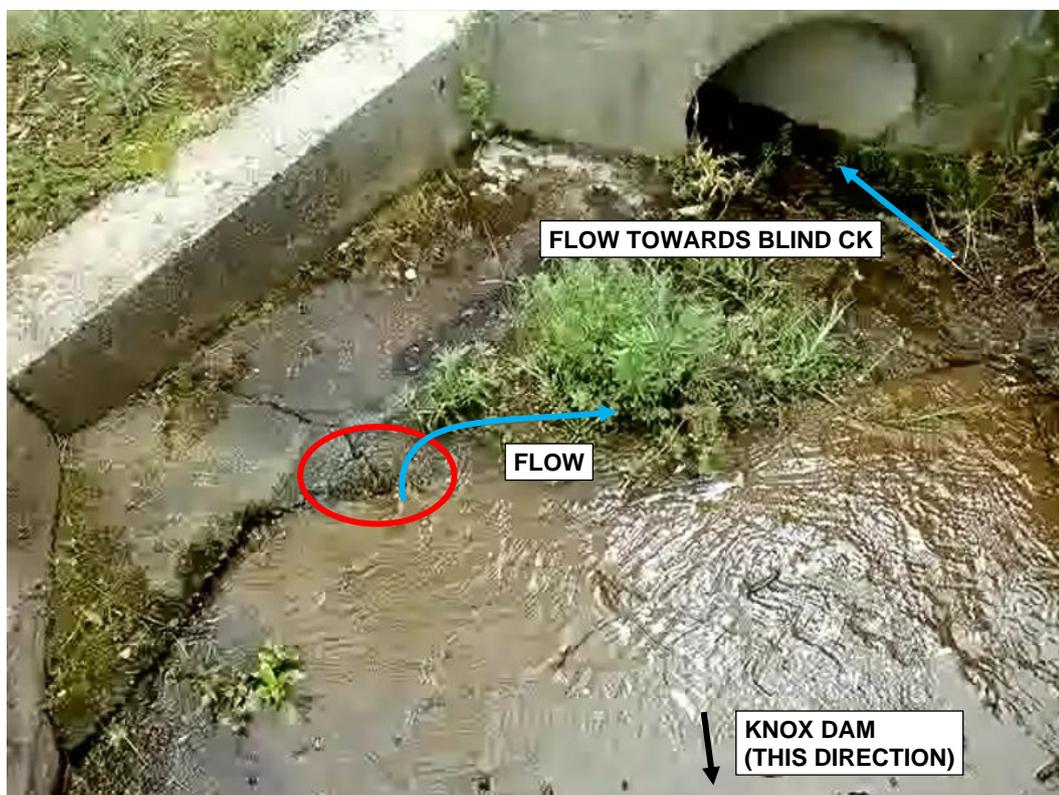
Figure 1: Flow emanating from underneath concrete slab (circled)

Based on the observations made during the inspection, the most plausible explanation for the water flow observed from beneath the slab is due to a combination of:

- Undermining of the slab due to wave action on the upstream batter, which may have resulted in gradual seepage-induced erosion of the soil beneath the slab (and formation of a permeable void), or may have exposed high permeability crushed rock (concrete bedding) beneath the slab;
- An open/unsealed joint between the two slabs of the upstream culverts and downstream culverts; and
- The dam water level reaching up to the level of the concrete joint.

- As soon as is reasonably practical from the issue of this document, provide temporary sealing of the visible void between the upstream and downstream culverts, using a cement-bentonite grout (bentonite is added to reduce the shrinkage cracking potential of cement-only grout). Grouting should be undertaken until no further grout can be added to the voids. Depending on the extents of the voids beneath the slab (as indicated by the grout quantities used), additional holes may be required to be drilled through the concrete and further grouting undertaken. The objective is intended to be short-term in nature only, to prevent / discourage further flow through the existing void and hence deterioration, until the scoping and detailed design of longer-term works can be completed and approved, and to minimise disturbance to the dam during bird nesting season.

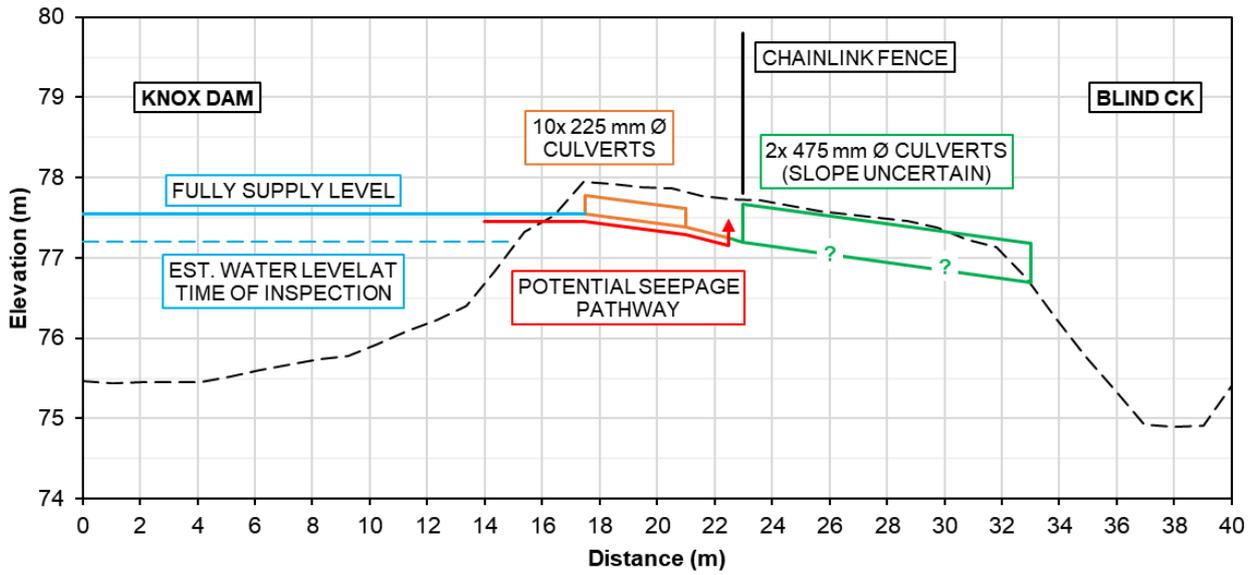
- The location where flow was observed to emanate from beneath the concrete is between the upstream and downstream culverts (refer Figure 3 for schematic, and Figure 4 and Figure 5 for photos).

Figure 3: Schematic of Knox Dam spillway cross-section (vertically-exaggerated) and observed water flow location (schematic based on survey provided by Development Victoria)

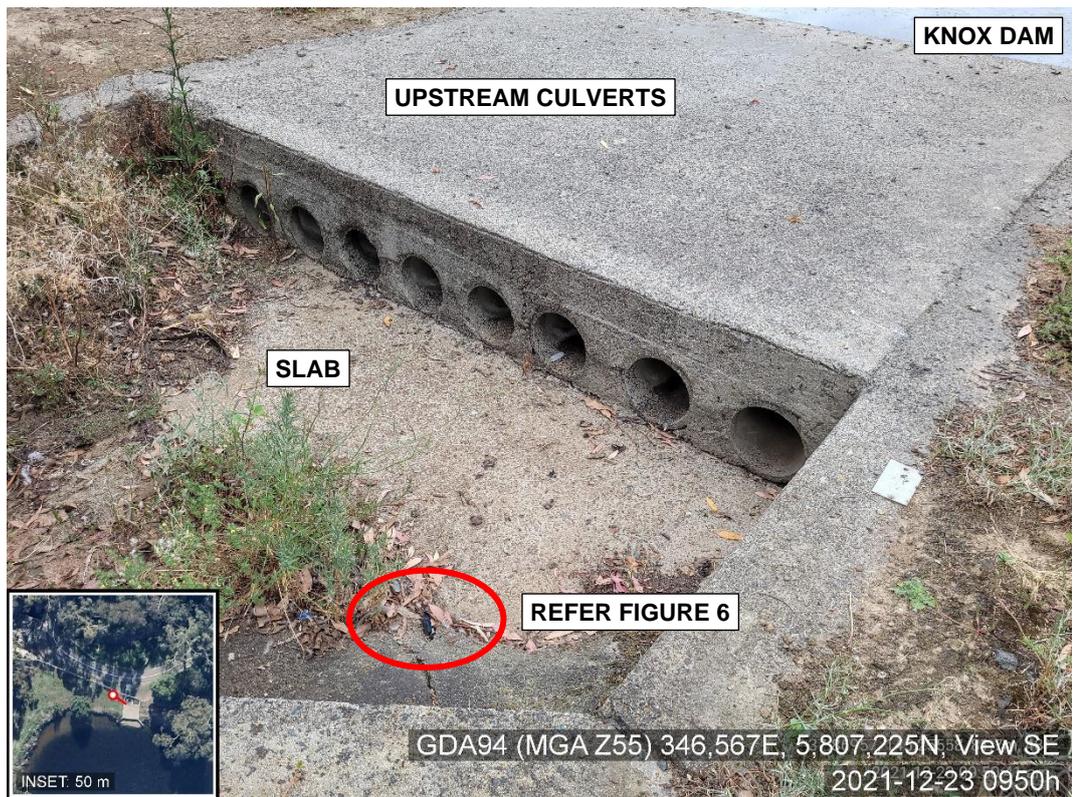
Figure 4: Location of past flow observations (circled); Knox Dam to photo top-right

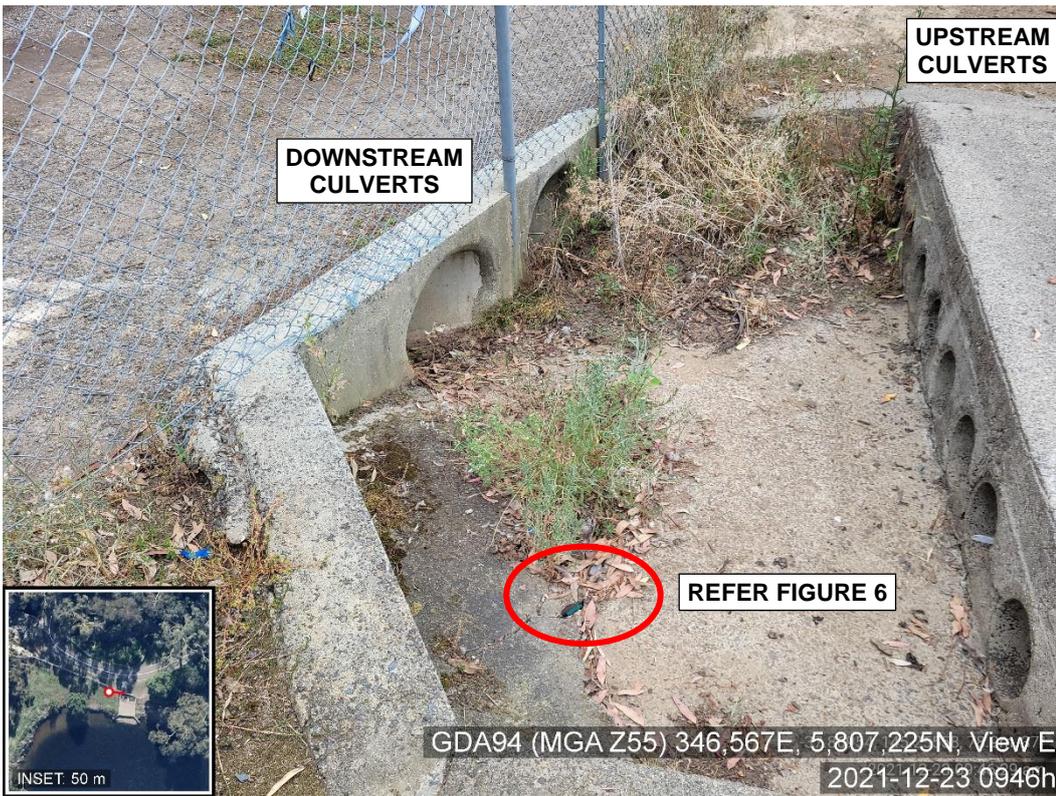
Figure 5: Location of past flow observations (circled); Knox Dam to photo right.

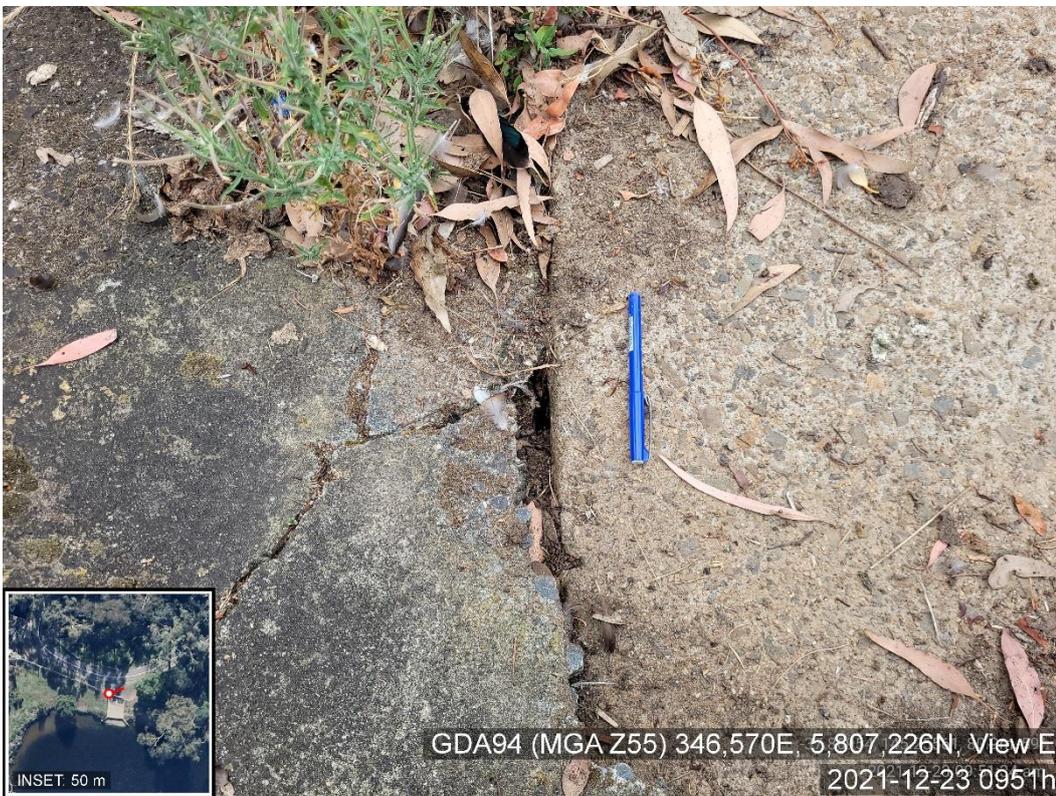
- A visible void was apparent where water had flowed through the concrete slab. Depth of the void was greater than 15 cm (refer Figure 6). It would also appear, from the condition of the concrete, that the two culvert structures may have been constructed separately or at different times, with the void forming at the interface of these structures.

Figure 6: Visible void in concrete slab (note also the difference in concrete)

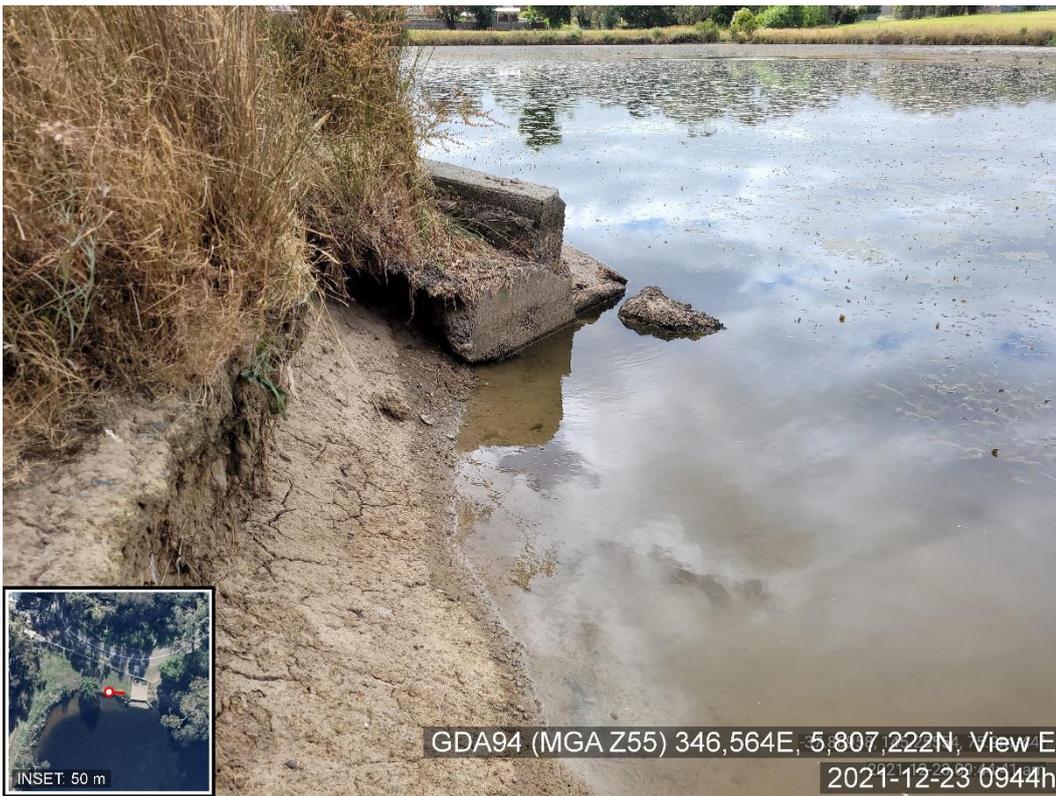
- There is significant erosion of the upstream slope of the embankment, which has resulted in a small vertical scarp on the batters and erosion behind and below the inlet of the concrete upstream culverts (refer Figure 7 and Figure 8), though they appeared to be in a similar condition as was recorded during an inspection in 2017.

Figure 7: Erosion of upstream embankment and erosion around/ undercutting of upstream culverts (western side)

- Within 6 months (long-term works) or as soon as can be arranged, demolish the existing upstream culvert. Excavate and replace with compacted low-permeability backfill any eroded / unstable soils beneath the original culvert. Replace the concrete inlet/ apron slab with dumped rock protection (and a concrete sill where required, including consideration of any opportunity to reduce the full supply level/ storage volume of the dam). Where undermining/ erosion beneath the downstream culvert exists, additional works may be required to cut-off any further potential seepage/ erosion pathways.

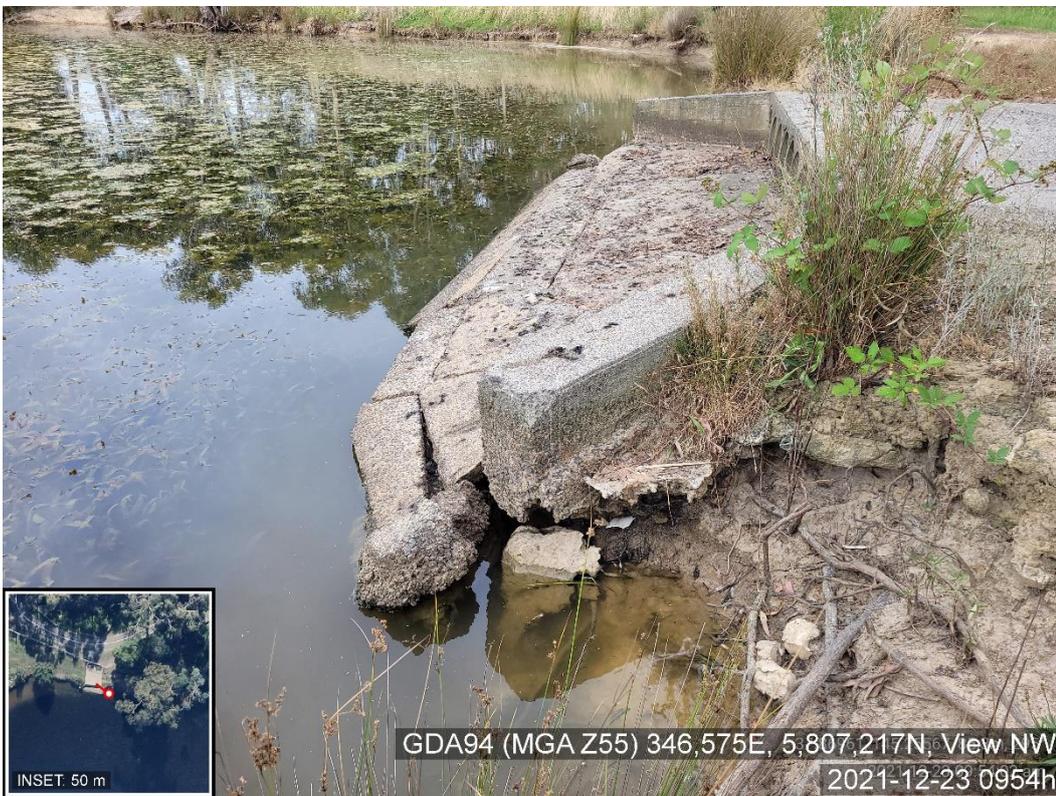
Figure 8: Erosion around/ undercutting of upstream culverts (eastern side)

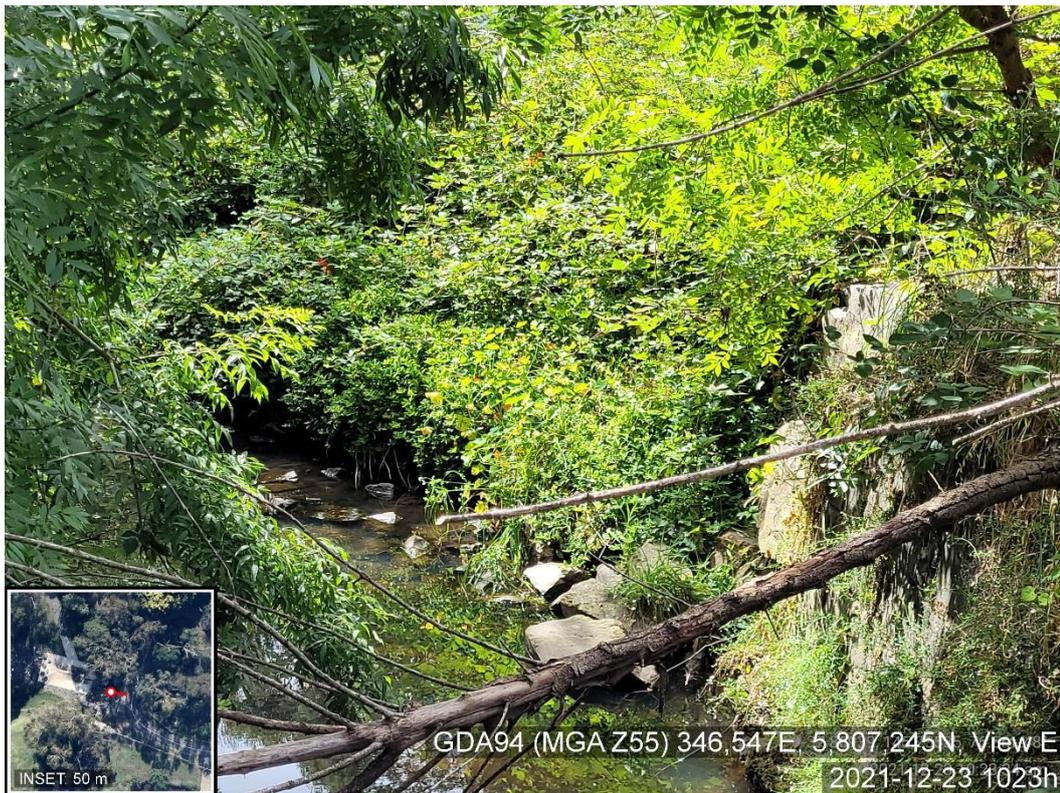
- Soils in the vicinity of the dam also appeared to be erodible, with mildly turbid water and common erosion / scour around nearby drainage pits.
- Observations could not be made downstream of the downstream culverts (near Blind Creek) due to the dense vegetation preventing observation of seepage/erosion features on the creek bank.

Figure 9: Blind Creek, heavily vegetated (increases difficulty to observe potential seepage from Knox Dam)

- Liaise with Melbourne Water to obtain permission to locally slash vegetation around the outlet of the downstream culverts (i.e. in Blind Creek) to allow inspection and monitoring of potential dam seepage (generally along Blind Creek, and specifically around the outlet of the downstream culverts).
- Regularly monitor dam water levels to identify any potential rapid (or quicker than expected) drops in water level, especially during high dam water levels, which may identify the existence of any other seepage mechanisms (and their location/elevation).
- Execute the recommendations as per the 2017 dam condition assessment report (Engeny 2017).
