Central Pier

Summary Fact Sheet

January 2020

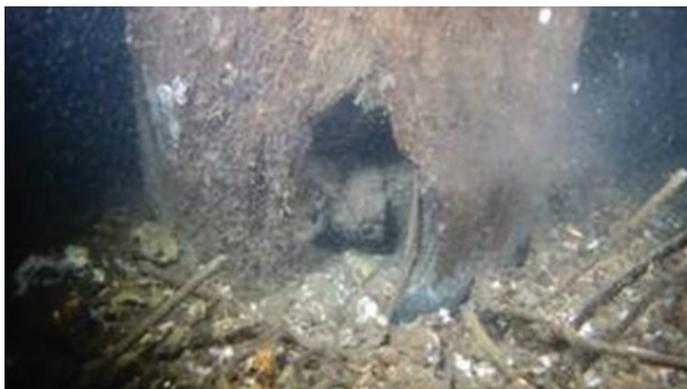
The 15-week investigation and assessment has revealed a rapid and severe deterioration of the deck and piles supporting the structure, despite previous repairs.

Image left and right: Rot, Marine borer and aggressive marine environment have continued to eat away at the structural supports
