13 January 2022

Development Victoria
Level 9, 8 Exhibition St, Melbourne VIC 3000
Sent via email

RE: CULVERT SPILLWAY INSPECTION OF KNOX DAM, 621 BURWOOD HIGHWAY, KNOXFIELD

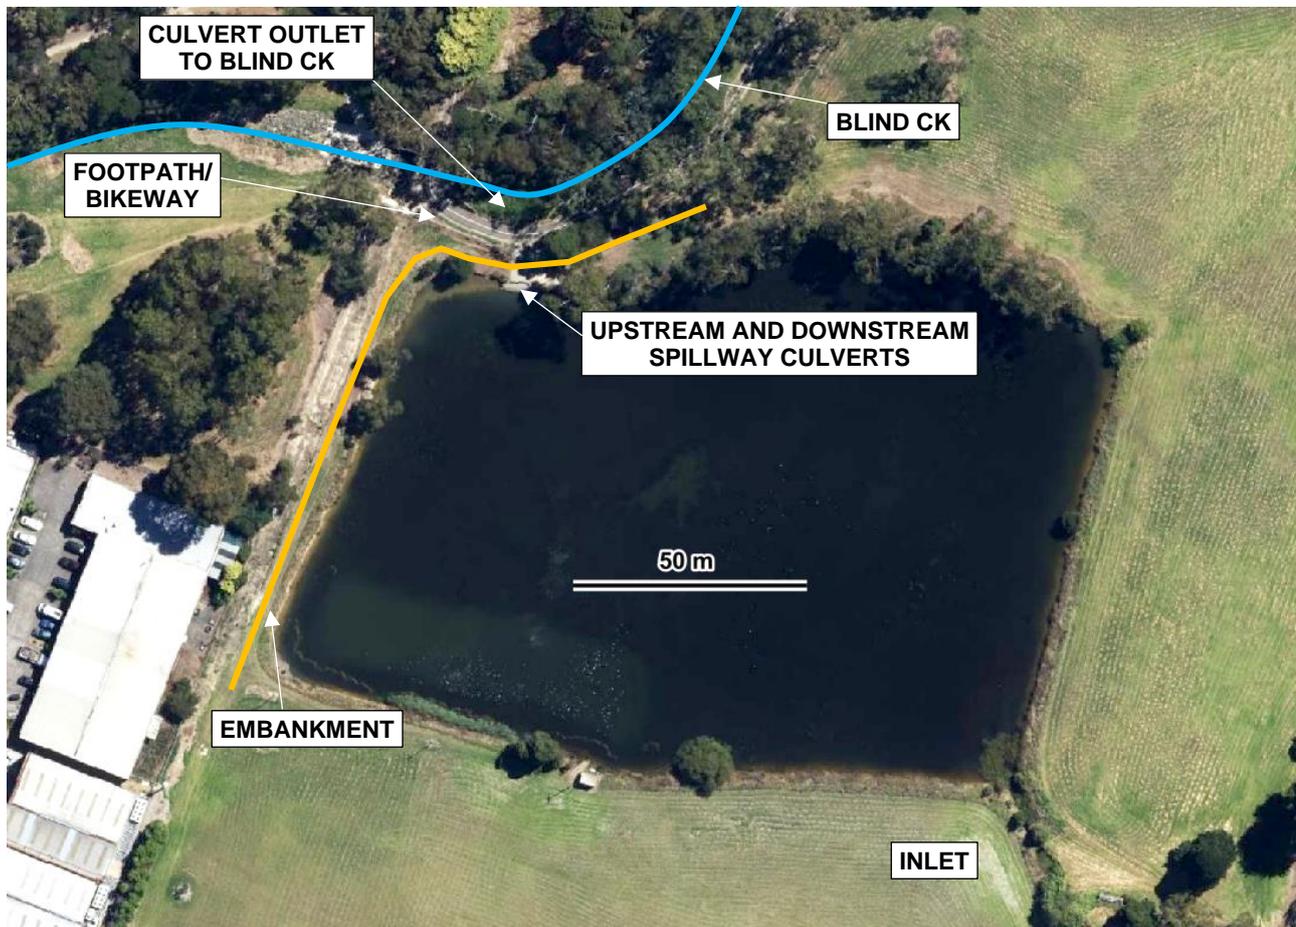
Figure 2: Knox Dam general layout

Limited design and construction information is available for the Knox Dam. Based on available information, it is understood that the Knox Dam is an approximately 31 ML water storage structure with embankments along the western and northern sides and a concrete culvert (overflow) spillway. The dam has a total catchment area of approximately 45 hectares, of which 1.6 ha is the dam's internal catchment. A general layout of Knox Dam is shown in Figure 2 below.
